Cleaning up the DSP Tracker's TX Output

By WA4ZKO

Last Updated: February 18, 2015

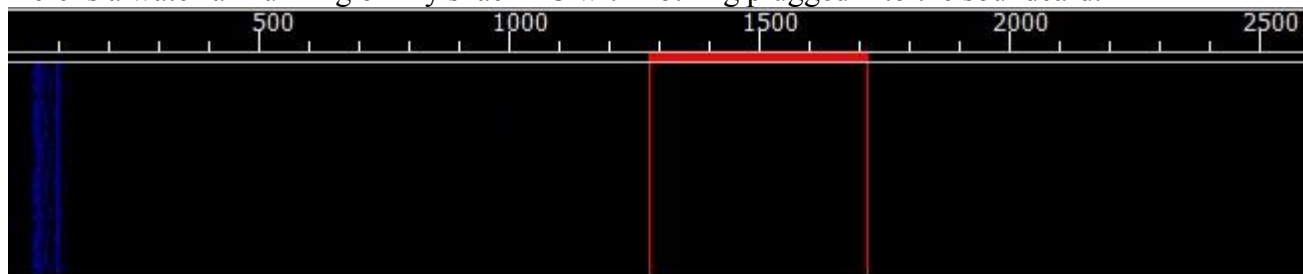
Here is a waterfall running on my shack PC with nothing plugged into the soundcard.

You will note just a bit of low level internal noise present down at the bottom of the waterfall at about 50 to 100 Hz. Make note of it and ignore that noise from here on forward as it is not coming from the Tracker. I have the red markers indicating an area 500 Hz wide centered at 1500 Hz on the waterfall where RP modulation would be present.

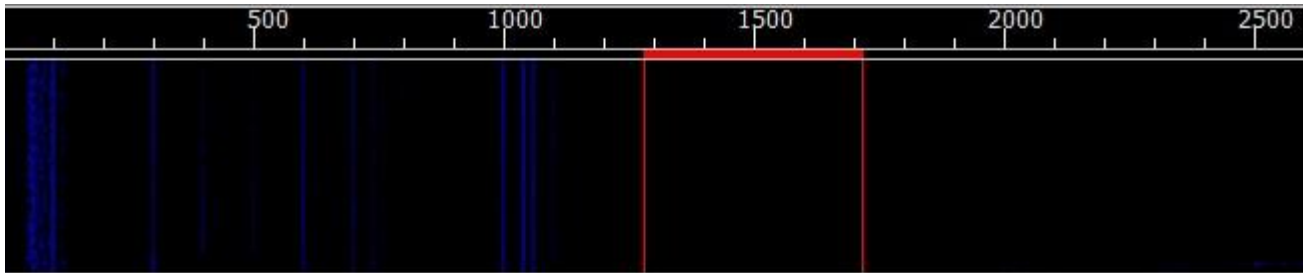
Now below I'll take the TX output line of the Tracker (idle) and plug it in for viewing on the waterfall:

Now you will note some noise on the above waterfall. Some at 300, 400, 600, 700 Hz and a mess around the 1000 Hz area. I have the tracker and the laptop on battery power so there is no chance that this is coming from AC/DC power supply ripple. This remains whether or not the USB cable is plugged in. Note that this is not a problem itself.....unless it's still there when the modem goes into transmit.

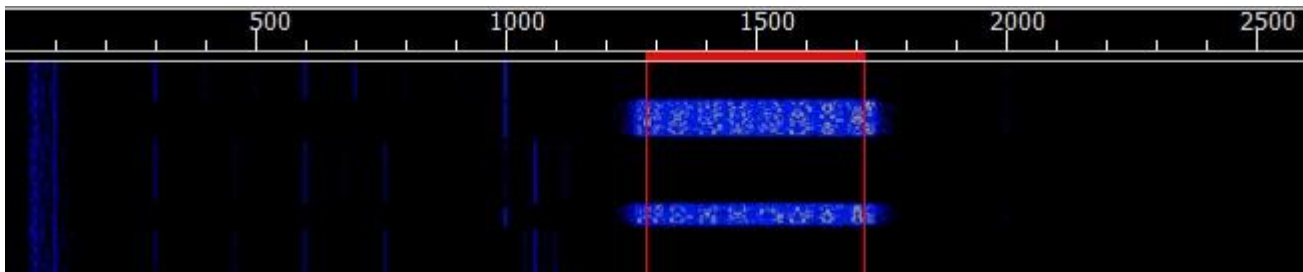
Okay, not good. Most of the noise is muted out during actual TX except we still have that noise there around 1000 Hz. That is going to get transmitted on the air at a pretty high level.

If your rig allows you to adjust the sensitivity (gain) of your data jack's input port then the fix is usually pretty easy. **Simply turn the gain on that port WAY DOWN and turn the modem's output up to compensate.** This makes the data port less sensitive to that low level noise while still getting plenty of TX audio drive from the modem to reach desired power output levels. Probably take some tinkering while watching a wattmeter, ALC meter, and your signal on another receiver's waterfall as you adjust things.

I dealt with interfacing my Tracker to the FT-450 by building up a modem to rig cable with a small high value resistor in it to pad the modem's TX audio line way down. Then I turned the modem's output up to compensate. A slightly better approach would probably be to add a variable resistor/voltage divider to the rig's data jack inside the case, but that was more rig surgery than I wanted to fool with.

What resistor values to try? Values in the 470k to 620k ohm range will usually do the trick.

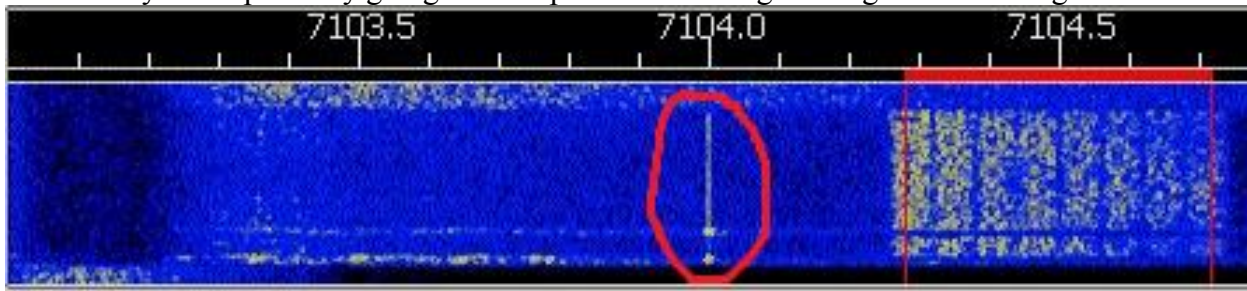
I've circled the problem in red. Ouch, right at the beginning of the two packets you will see pretty big TX "chirps" at 1000 Hz followed by that thin carrier from the noise noticed above.

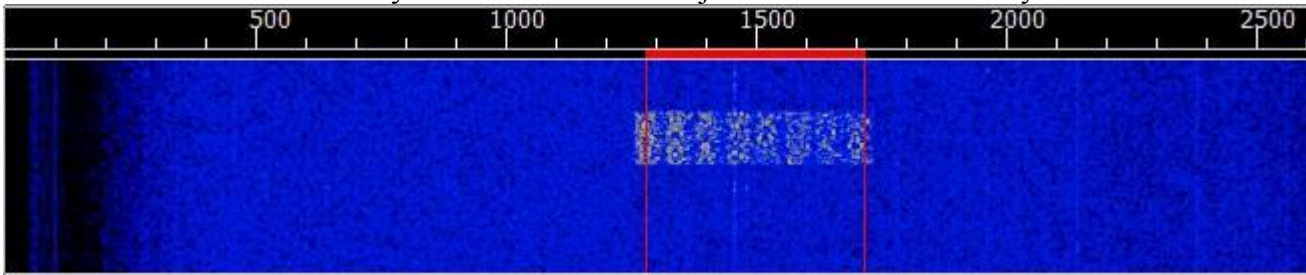
So what would a clean RP signal look like? Here is one I captured live from my node doing a manual R300 beacon on 30m. The very faint vertical lines are just local noise here at my home station:
